PEB#000079
Recall of Certain Plastic Ripcord Handles Optional
1979

Relative Workshop Recalls. Certain Plastic Reserve Ripcords

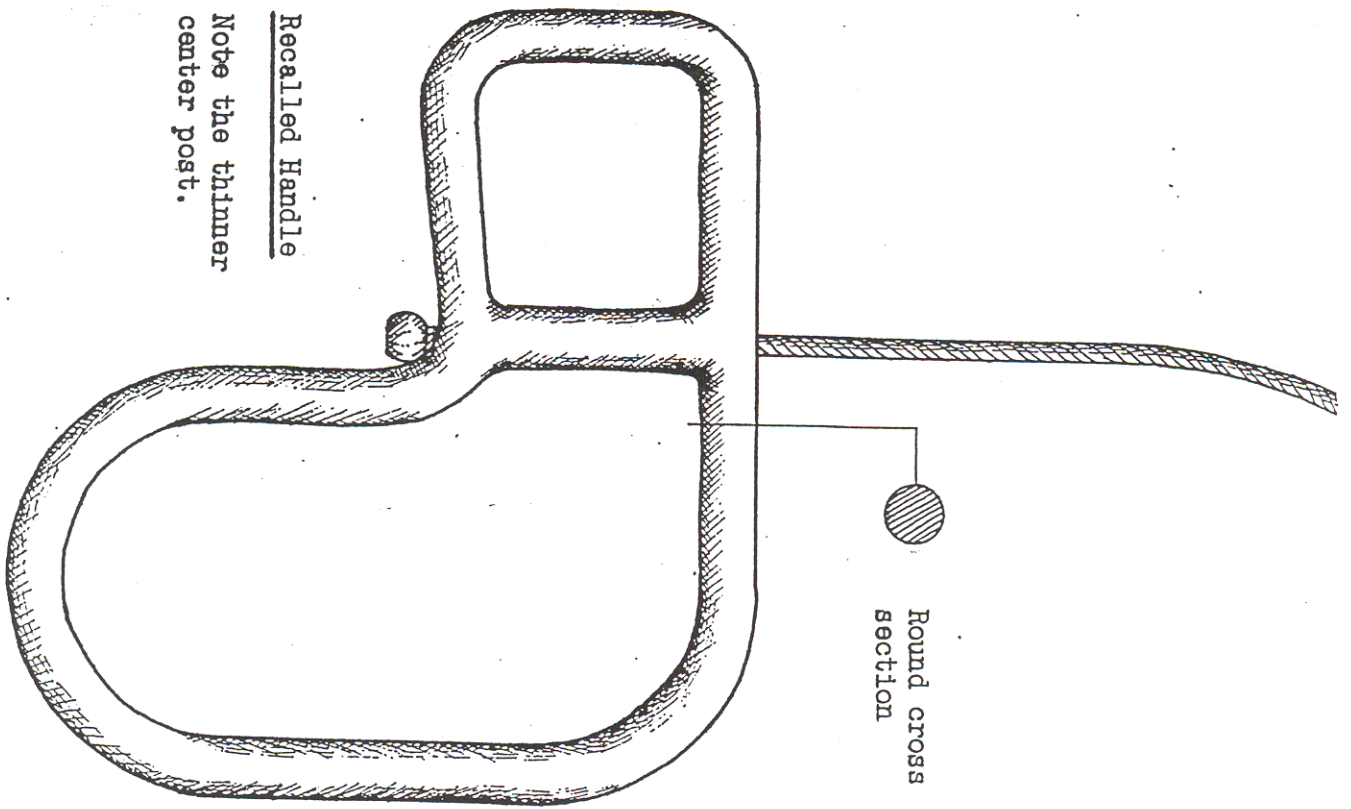
Recalled Handle

Very recently the Relative Workshop learned of two documented instances where plastic reserve ripcord handles failed when pulled in the air. Although the incidents did not involve Wonderhogs, the ripcord handles were of the same type and source as those used on some Wonderhogs. The handles that failed were both over two years old, significantly older than even the oldest ones used on some Wonderhogs.

The ripcords being recalled were obtained from the Jump Shack, Inc. They are made of tan nylon, have a round cross section and a smooth finish, The cable passes through a post that has the same diameter as the rest of the handle.

Note the thinner center post.

Round cross section

Although no injuries resulted from these failures, the Relative Workshop has decided to replace ripcords of this particular type with ones with metal handles. Owners of Wonderhogs equipped with these handles may receive a replacement ripcord by returning the plastic one and the information specified below directly to the Relative Workshop.

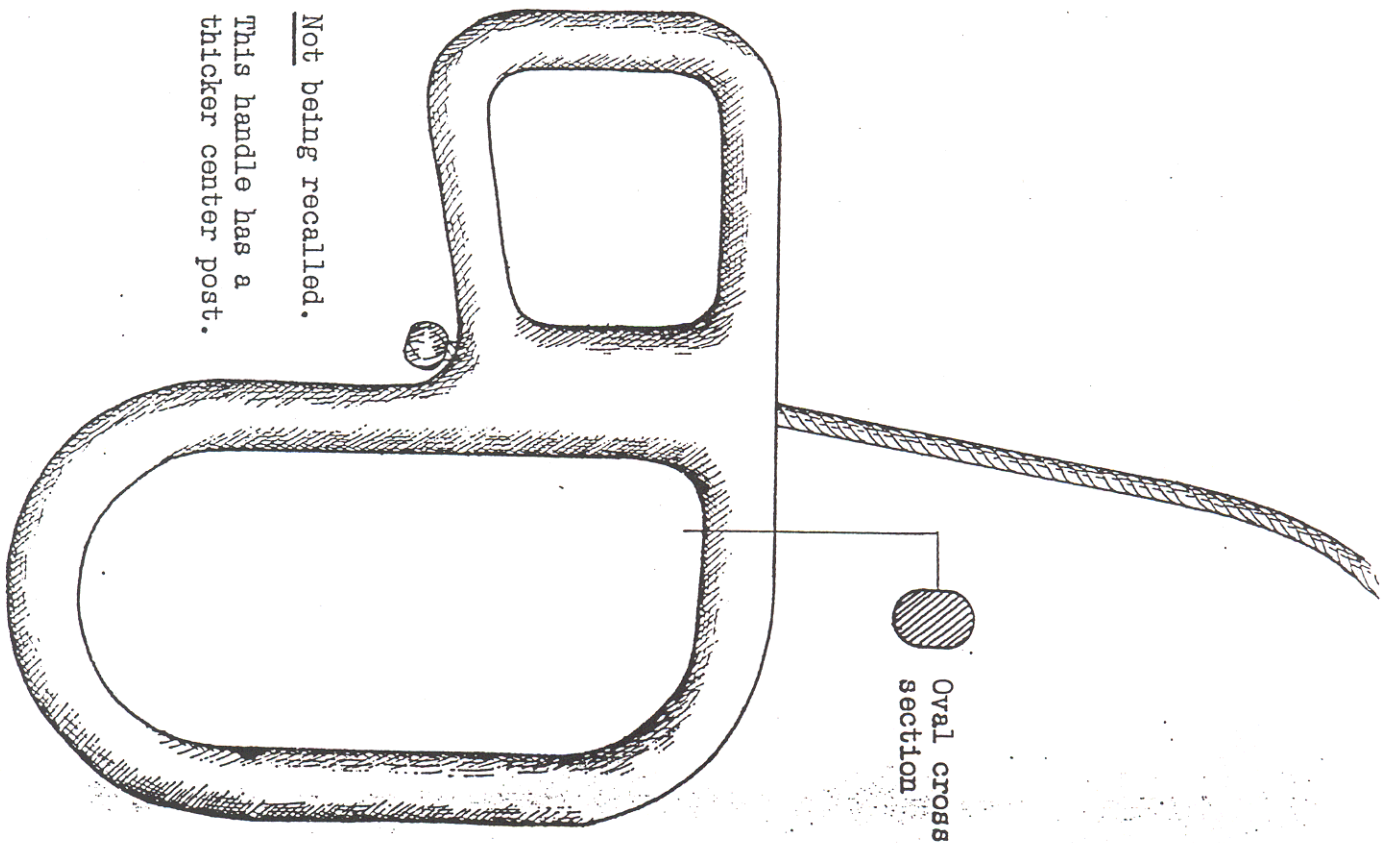
Not being recalled.

This handle has a thicker center post.

Oval cross section
