PSB#071085 Replace Plastic Disk Slider Stop with Metal Washer July 10, 1985

TANDEM NOTICE!

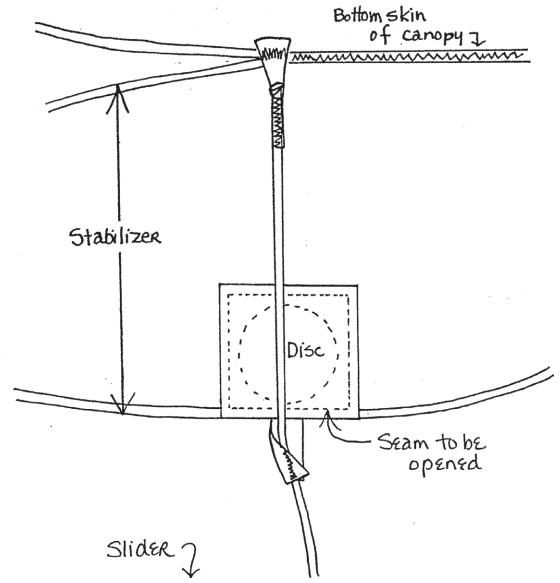
WE HAVE REPORTS OF TWO (POSSIBLY MORE) INSTANCES OF TANDEM SLIDERS PASSING OVER THE SLIDER STOPS SEWN ON THE STABILIZERS.

THE SEAM AT THE BOTTOM OF THE SLIDER STOP POCKETS MUST BE OPENED, THE PLASTIC DISK REMOVED, AND THE METAL WASHER INSERTED. THEN RESEW THE BOTTOM OF THE POCKET. THIS MAY BE HAND TACKED CLOSED IF THERE IS NO MACHINE ACCESS. PLEASE SEE THE ATTACHED PICTURE.

THIS MUST BE DONE ON BOTH THE MAIN AND RESERVE BEFORE YOUR NEXT JUMP.
