SERVICE BULLETIN

Date: 5/23/2005
Service Bulletin #: PDSBLTN-002, RWSBLTN-230505
Subject: Inspection of Tandem VTC-III reserves (VR-360) A Line Attachments and Steering Lines.
Status: MANDATORY

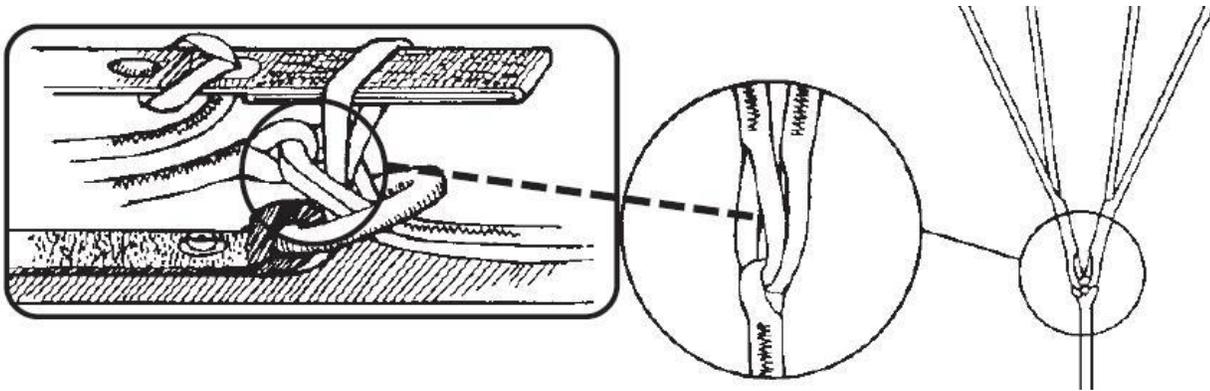
Some VR-360's were manufactured with the lower control line loop to be as large as the upper control line loop at the cascade. While there is no impact to the structural integrity, or performance of the canopy, this situation opens the possibility for the riser brake-setting loop to be misrouted through the lower control line instead of the correct location in the upper control line as shown below. Improperly set brakes can result in brake line failure during opening and unusually high opening forces.

Correct Brake Setting

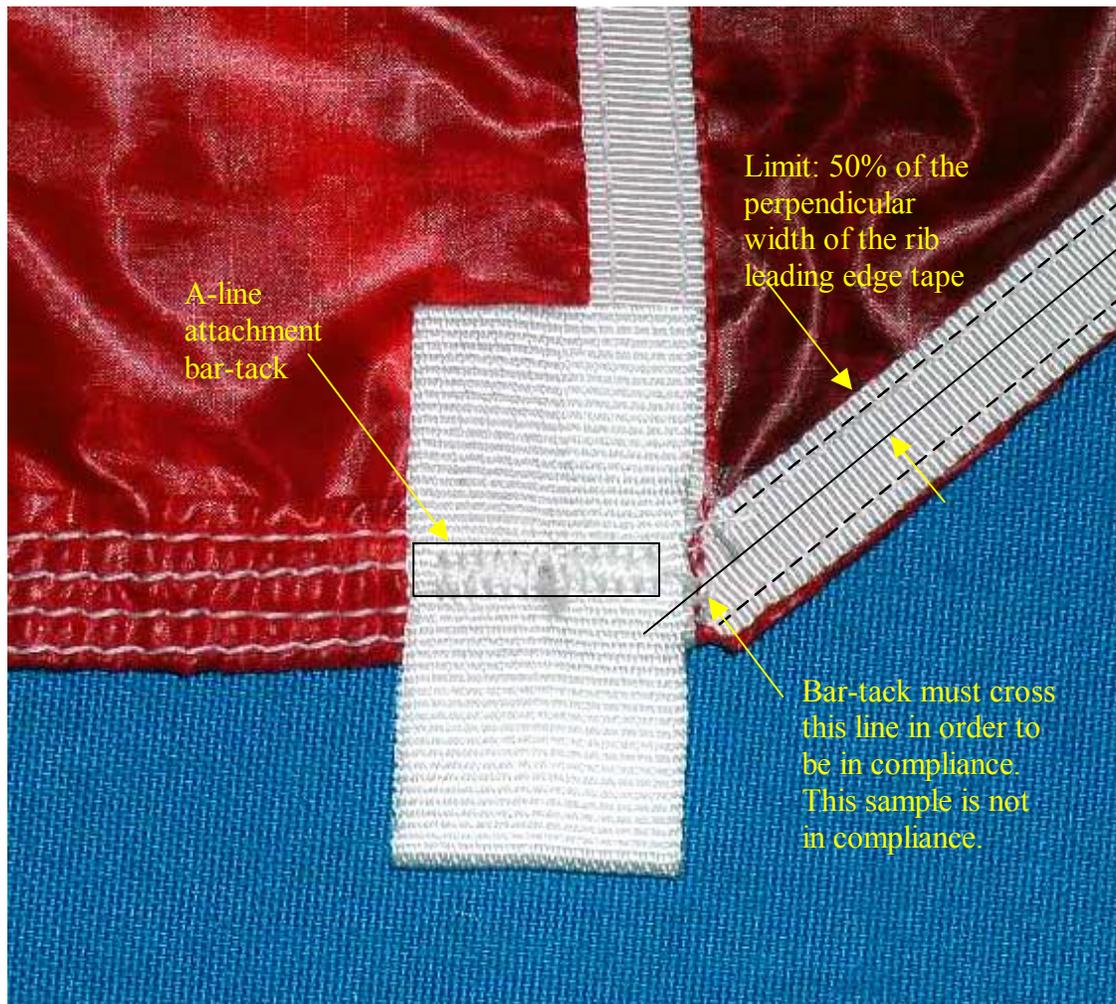
Figure 1 Rib leading Edge Tape Inspection

The A-line attachment bar-tack must be sewn through at least 50% of the width of the loaded-rib leading edge tape.

- Using a ruler, find the centerline of the rib-leading edge tape. This may be lightly marked with pencil if necessary.
- Using the ruler, extend the centerline of the leading edge tape to the vicinity of the bar-tack.
- Observe the location of the bar-tack with respect to the tape centerline.

1. Inspect all ten of the A-line attachments per the attached Inspection Procedures, Section 1, A-line Attachment Inspection Procedure.
2. If any of the 10 A-line tab bartacks do not comply with the proper alignment the parachute must be brought into compliance by an approved service facility. Adjusting the line tab requires a specialized heavy-duty bartacker not commonly found in the field.

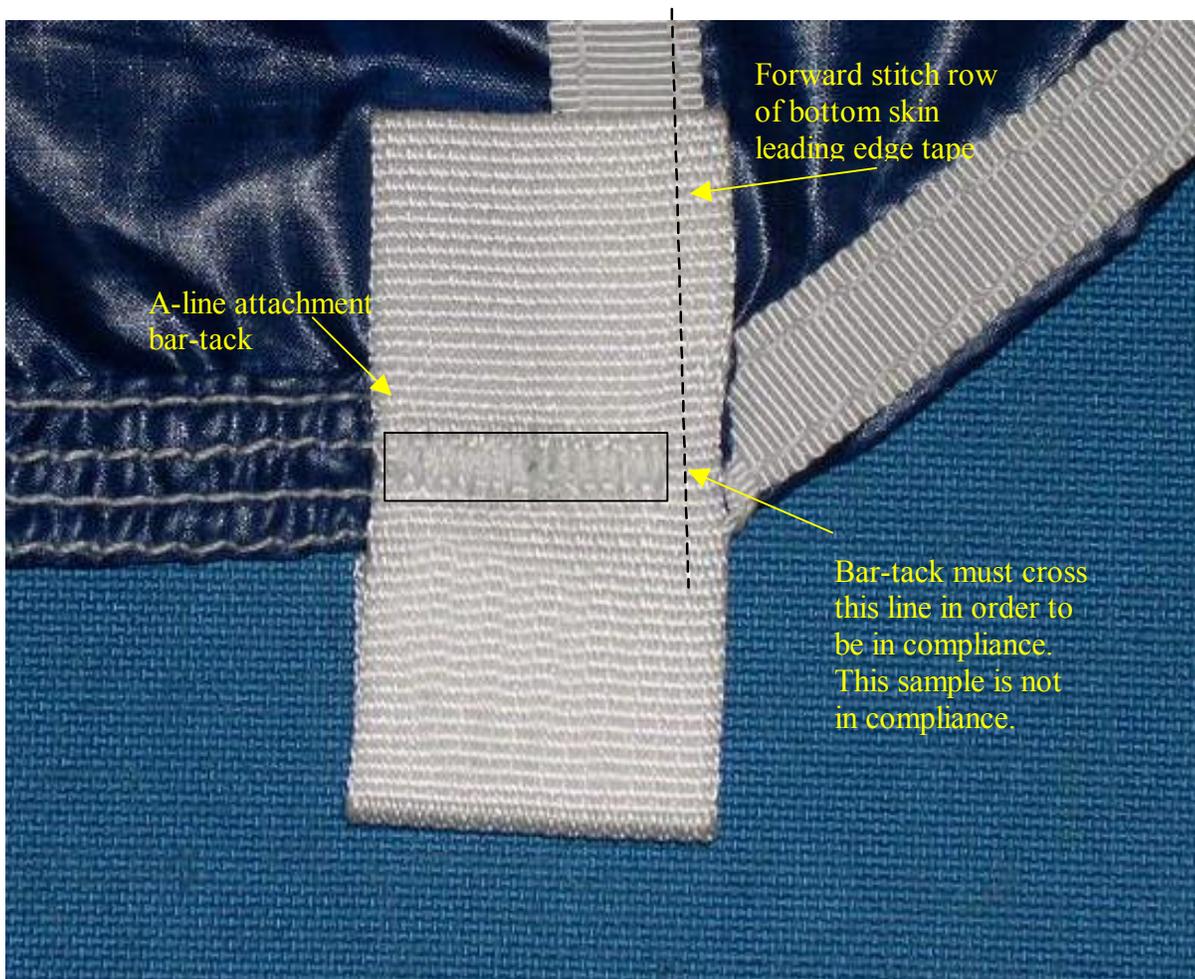
Figure 2- Bottom Skin LE Tape Inspection

The A-line attachment bar-tack stitching must extend forward of the forward stitch line on all the bottom skin leading edge tapes. Inspect both sides of tab.

- Locate the forward stitch row of the bottom-skin leading edge tape.
- Using a straight edge, extend the forward stitch line of the leading edge tape to the vicinity of the bar-tack.
- Observe the location of the bar-tack with respect to the tape stitch row. The bar-tack may or may not overlap the edge of the line-tab, but it must cross the stitch-row and be going through the tab at this point.

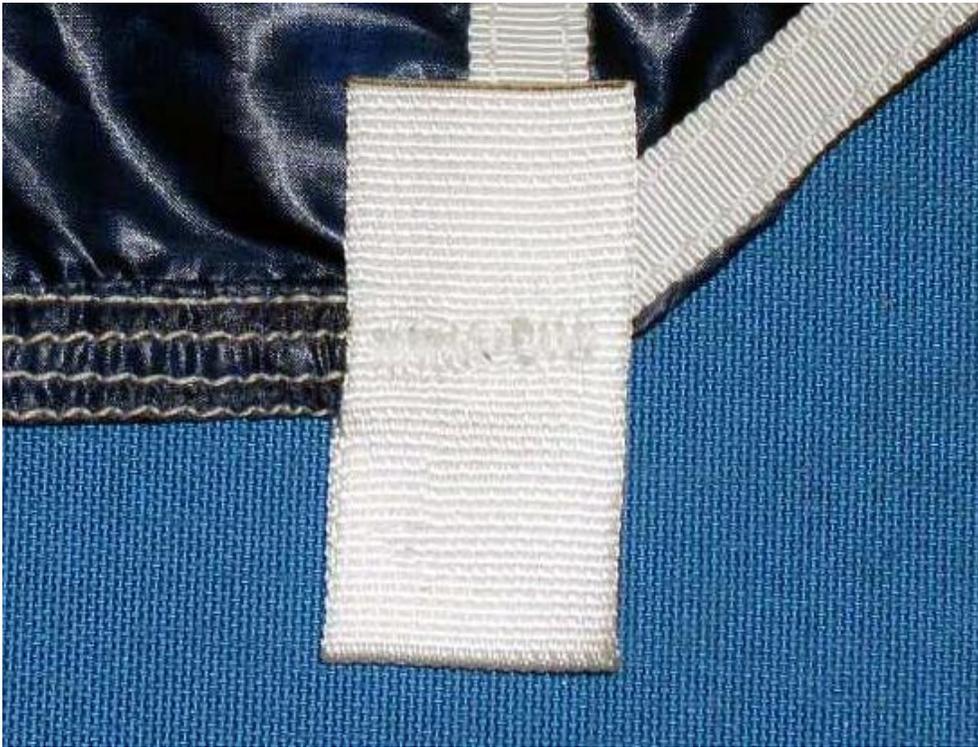
Figure 3 Acceptable Line Attachment Bar Tack

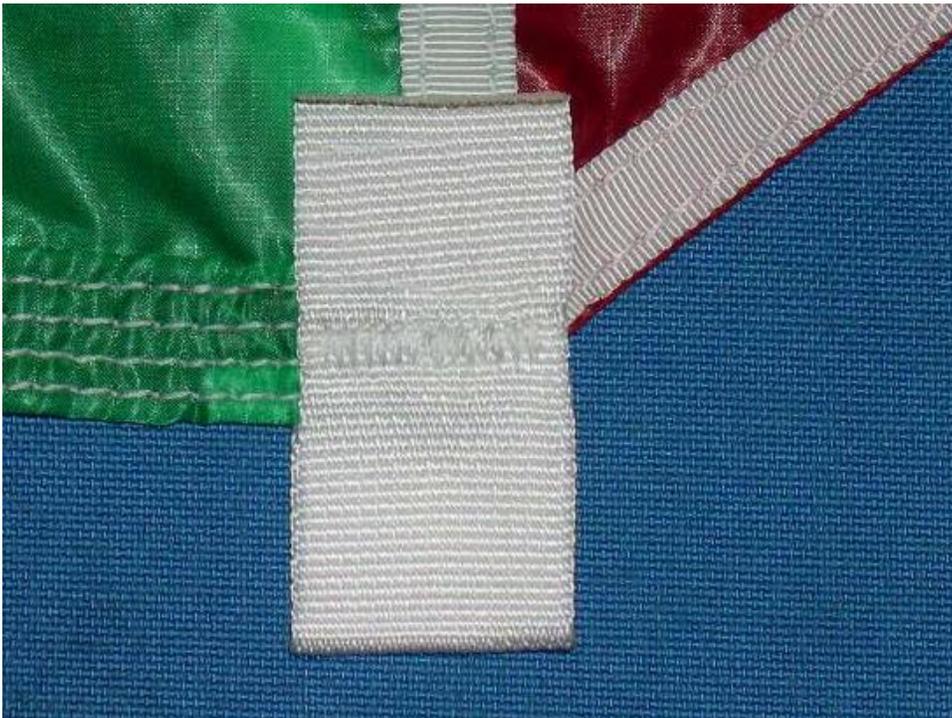
Figure 4 Acceptable Line Attachment Bar Tack

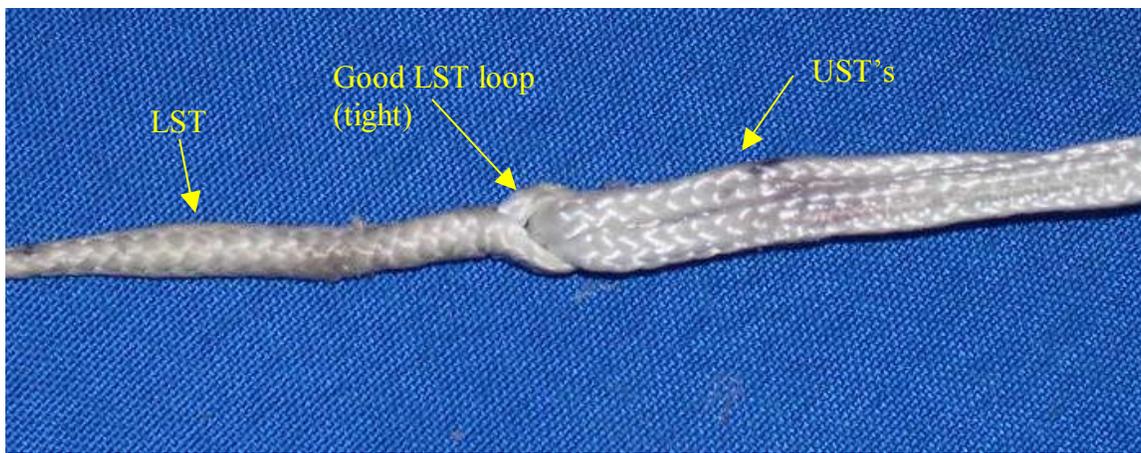
Check each of the LST's (lower steering lines, the line that passes through the toggles) where it loops around the UST (upper steering line). This loop must be small enough that the brake setting loop on the risers cannot be pulled through.

Figure 5 Good LST Loop

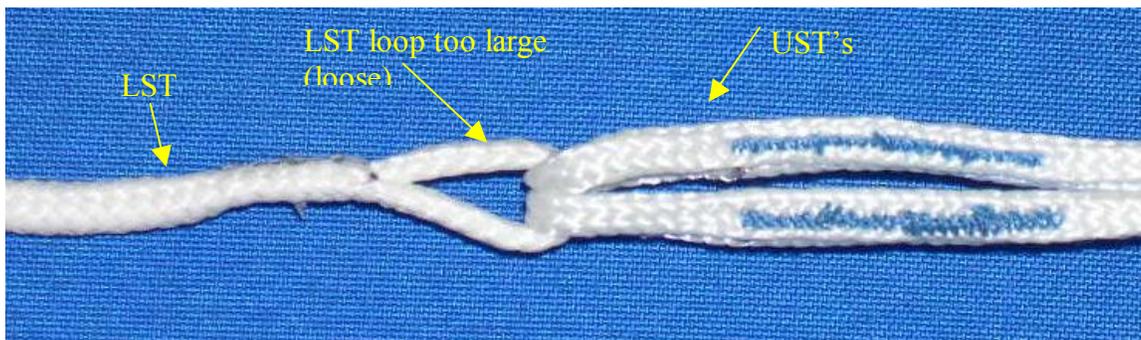
Figure 6 - LST Loop too large

The LST loop may be reduced to an acceptable level by adding a bar-tack or zigzag stitch to reduce the open legs of the loop. The following includes directions for reducing the existing LST loop.
